VAN BUREN COUNTY
JOE PARMAN, DRAIN COMMISSIONER

DAM INSPECTION REPORTS

APRIL, 2011

PROJECT NO. 9527-6

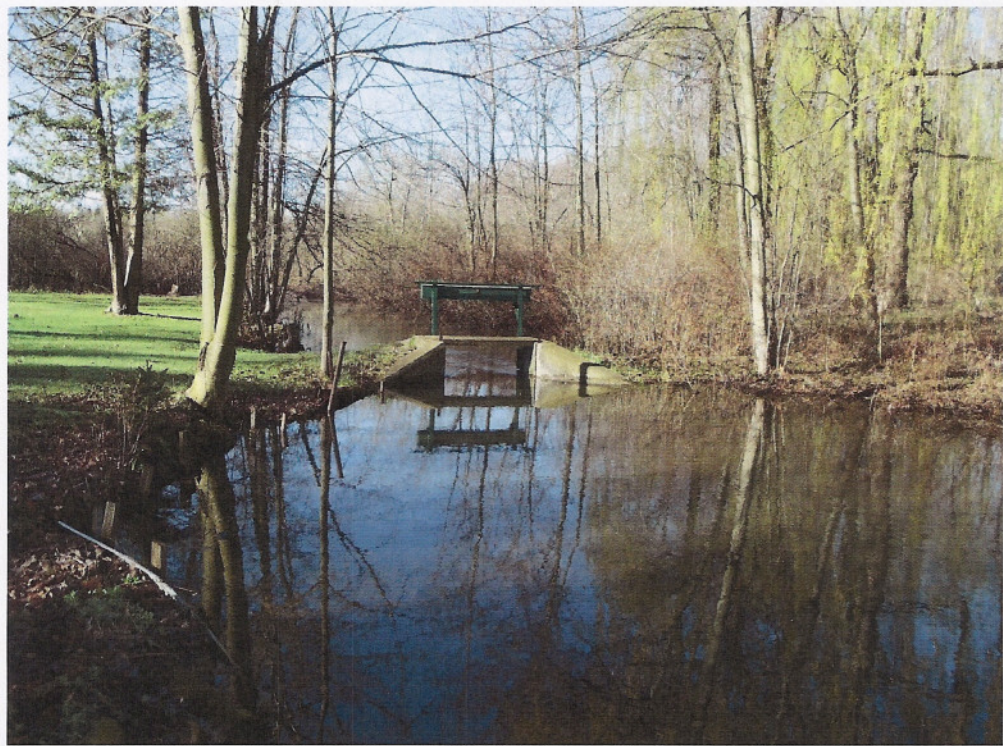
LEVEL CONTROL STRUCTURE – STOPLOG RAISED

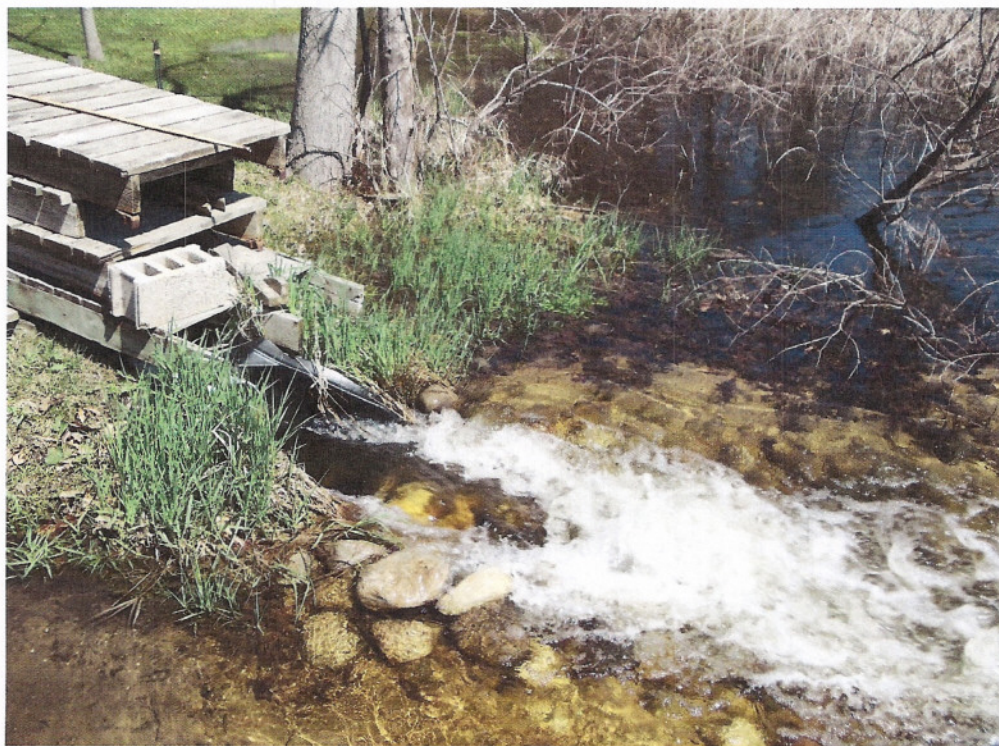
STOPLOG VALVES AND GATES (open and close to check condition): Check location of top stoplog in relation to top of riser pipe intake box or fixed crest, for leakage, and condition of stoplogs, valves and gates. None
OUTLET PIPE: Check for damage from ice, logs, vandalism; inside discharge pipe for settlement and/or joint separation; condition of pipe coating. Outlet Pipe has been extended to edge of Saddle Lake.

OUTLET PIPE (WITH END SECTION REMOVED)

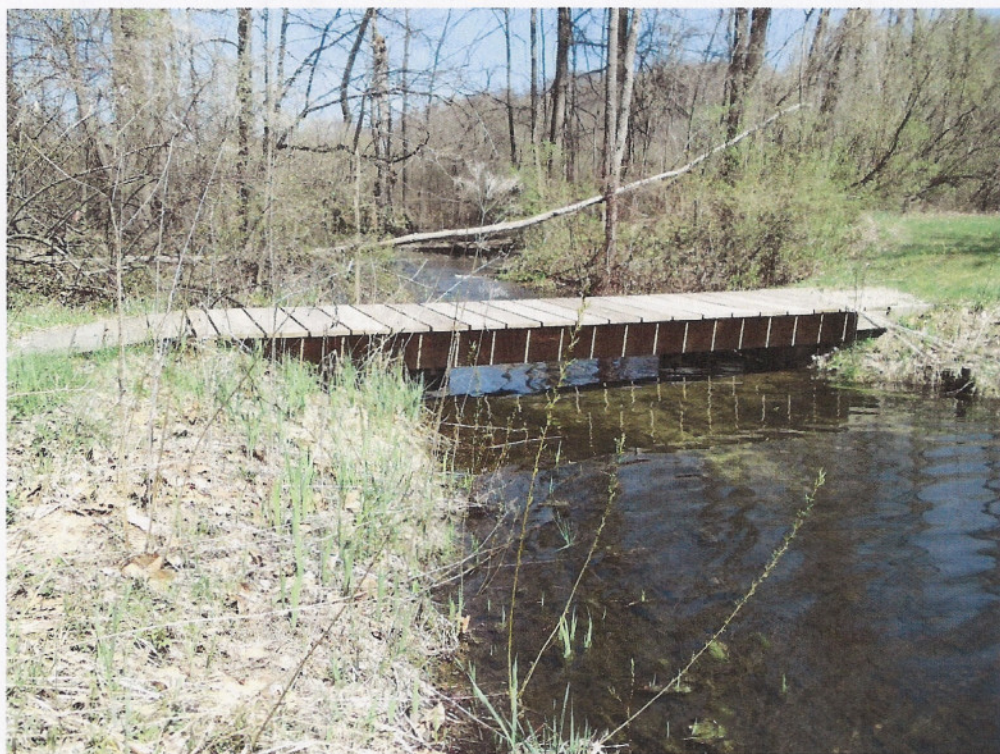
CONTROL STRUCTURE
(UNDER WOOD BRIDGE)

Wooden foot bridge has been replaced.

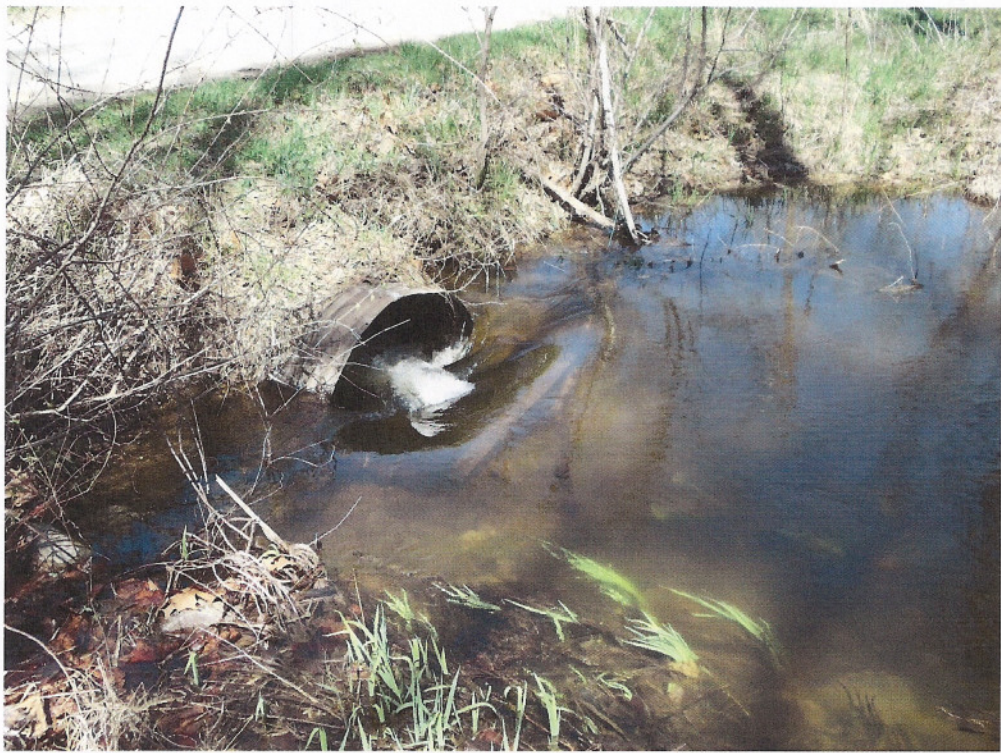
CONTROL STRUCTURE AND OUTLET PIPE

INLET	OUTLET
SIZE	30'	12'
EXISTING CONDITION	Good	Good
EROSION	None	None
DEBRIS & OBSTRUCTIONS	None	Good
RIPRAP PROTECTION		Banks of outlet channel are becoming scoured
REMARKS*		Riprap protection is needed for outlet channel

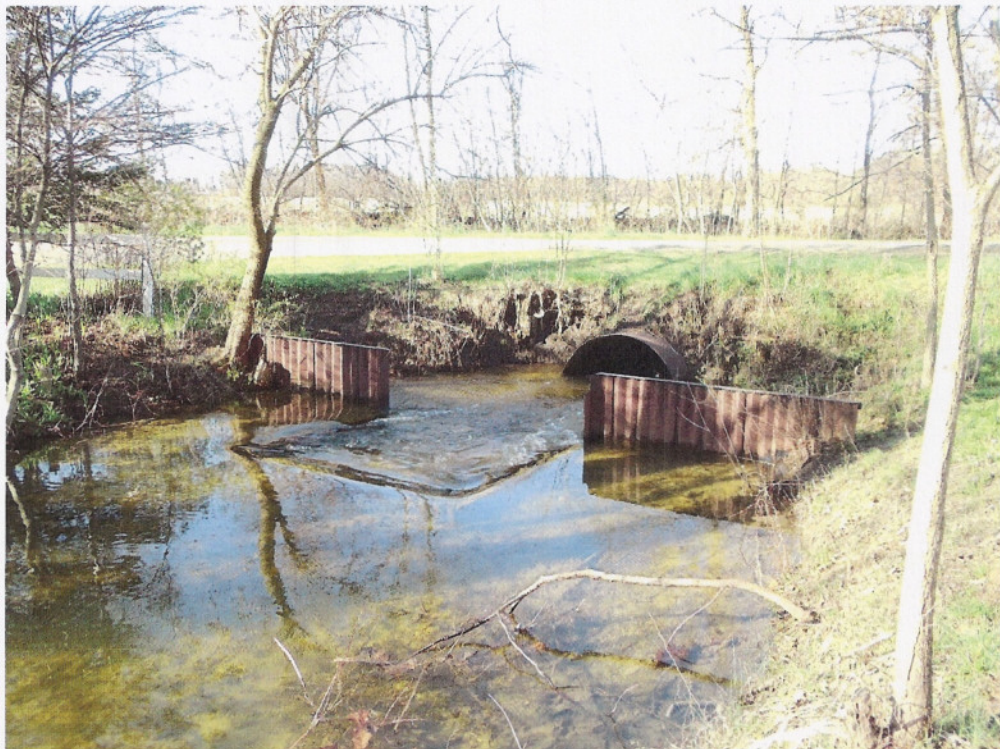
Both steel sheeting wingwalls are developing holes from corrosion. Consideration should be given to repair or replacement of the structure. Trees and brush growing adjacent to the wingwalls should be removed.

CONTROL STRUCTURE – CORRODED STEEL WINGWALL

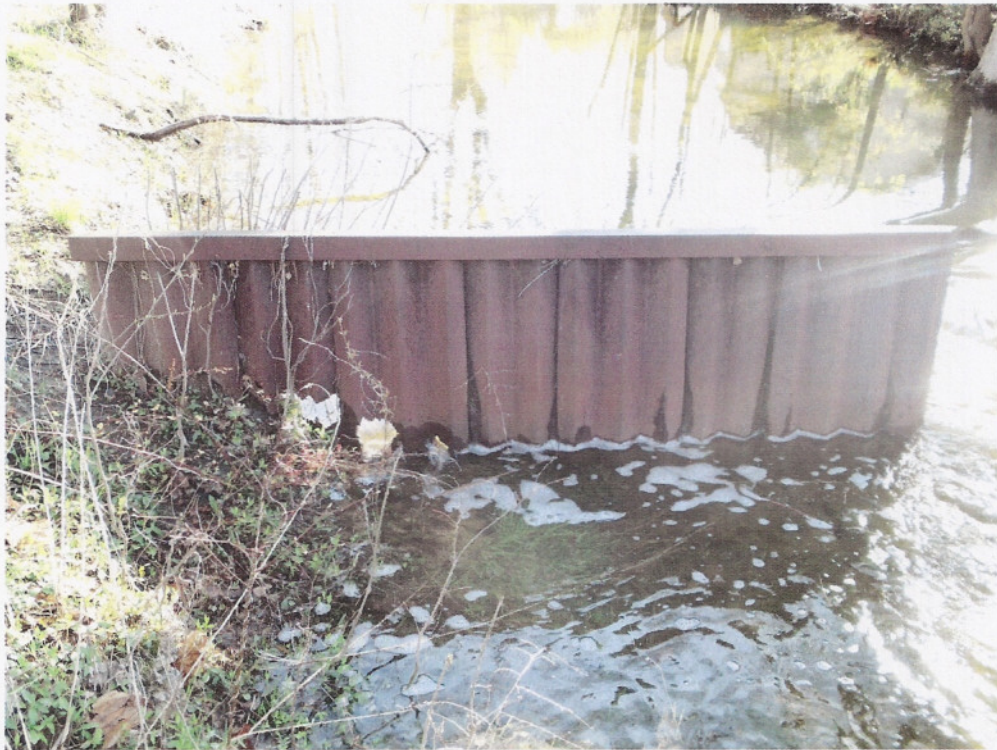
CONTROL STRUCTURE – CORRODED STEEL WINGWALL

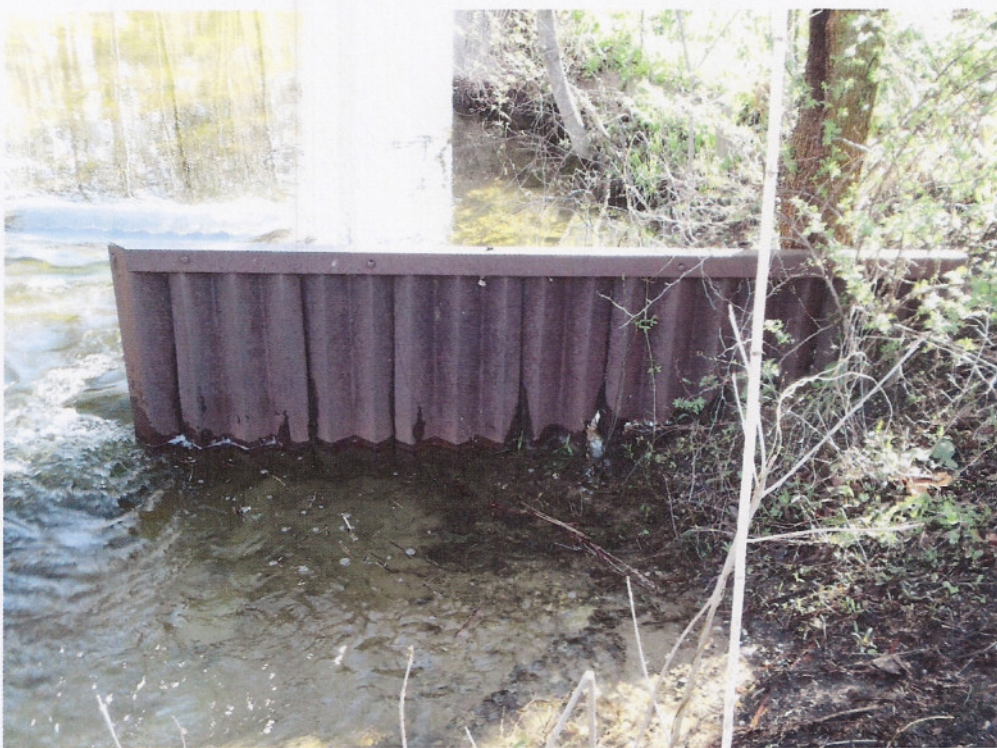
CONTROL STRUCTURE – CORRODED STEEL WINGWALL
